Failure of Sella Zerbino Secondary Dam in Molare, Italy

Irfan A. Alvi, PE, President & Chief Engineer, Alvi Associates, Inc.

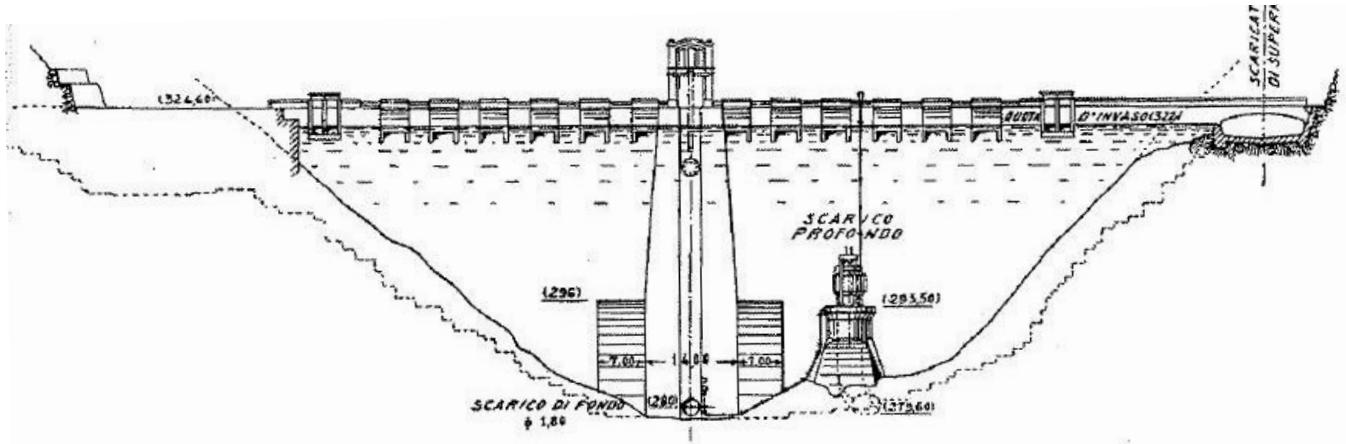
The Bric Zerbino main dam was a curved concrete gravity dam about 154' high (Figure 4), located on the Orba River. Discharge from the dam was via a valved bottom outlet (Figure 5), a mid-level pressure outlet with inflow through a shaft with a valved intake (Figure 6), 12 siphon spillways (Figure 4), and a gated chute spillway (Figure 4), providing a total discharge capacity of about 31,000 cfs [6]. This discharge capacity represented an increase from the originally planned capacity, in response to the 1923 failure of Gleno dam in northern Italy after heavy rain [3], which had resulted in at least 356 fatalities.

Figure 4. Upstream Face of Main Dam

- By 10:00 am, the reservoir level had risen about 25’ and the dam caretaker started an emergency procedure, apparently opening the valves for the bottom outlet and mid-level outlet of the main dam, but the valves became clogged with a large amount of mud and debris within a few minutes [4]. The siphon spillways had a discharge capacity of about 23,000 cfs (less than one third of the peak inflow), and they may also have become partially clogged [3]. There is also indication that a gate for the chute spillway was at least partly inoperable due to rust [3].

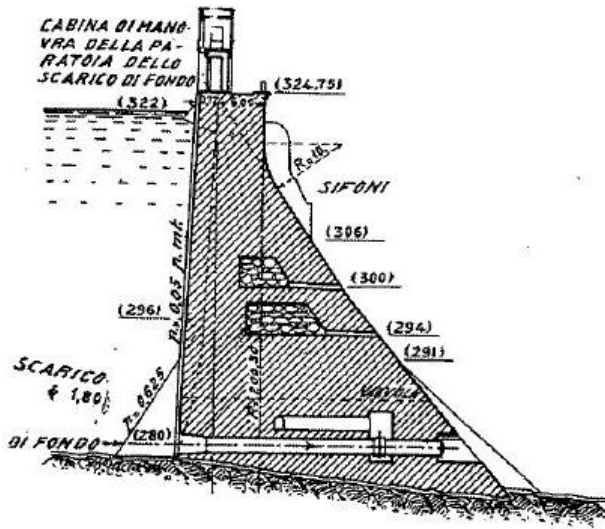
Figure 5. Bottom Outlet of Main Dam

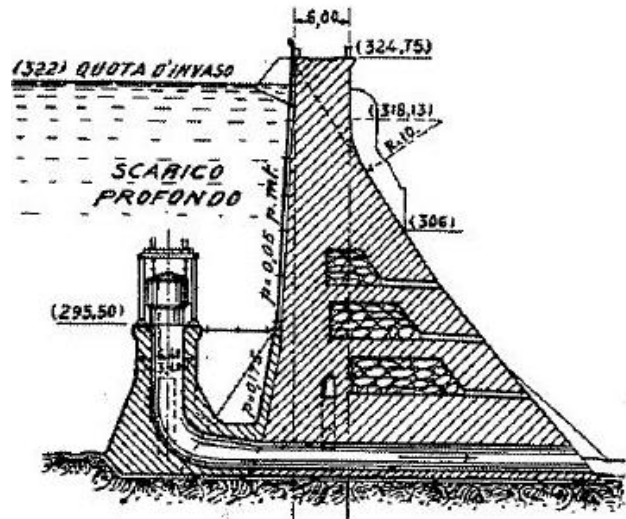
Figure 6. Mid-Level Outlet of Main Dam

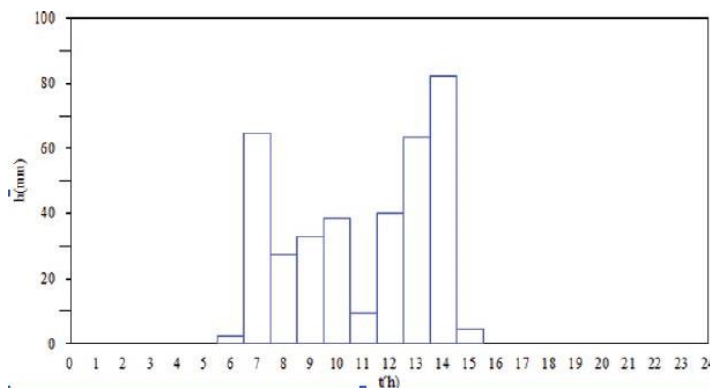
- Around 6:15 am on August 13, 1935, after a long drought which had caused the reservoir level to be very low for several weeks despite closing the outlet valves, a very heavy storm began in the upper Orba valley, producing 15” of rain in less than 8 hours, and more than 30% of the average annual rainfall within 24 hours. The most intense rain was from 7:00 am to 8:00 am and from 2:00 pm to 3:00 pm, but there was also heavy rain between 8:00 am and 2:00 pm (Figure 9). The peak inflow to the reservoir immediately prior to the failure is estimated at 80,000 cfs (Figure 10), and the storm is estimated to have been a 1000-year event [5].

Figure 9. Rainfall Hyetograph on Day of Failure [5]
