# Dam Safety

VOLUME 9 | ISSUE 3 | 2011

# GATEHOUSE ANCHORAGE System for Prettyboy DAM

IRFAN A. ALVI, P.E.

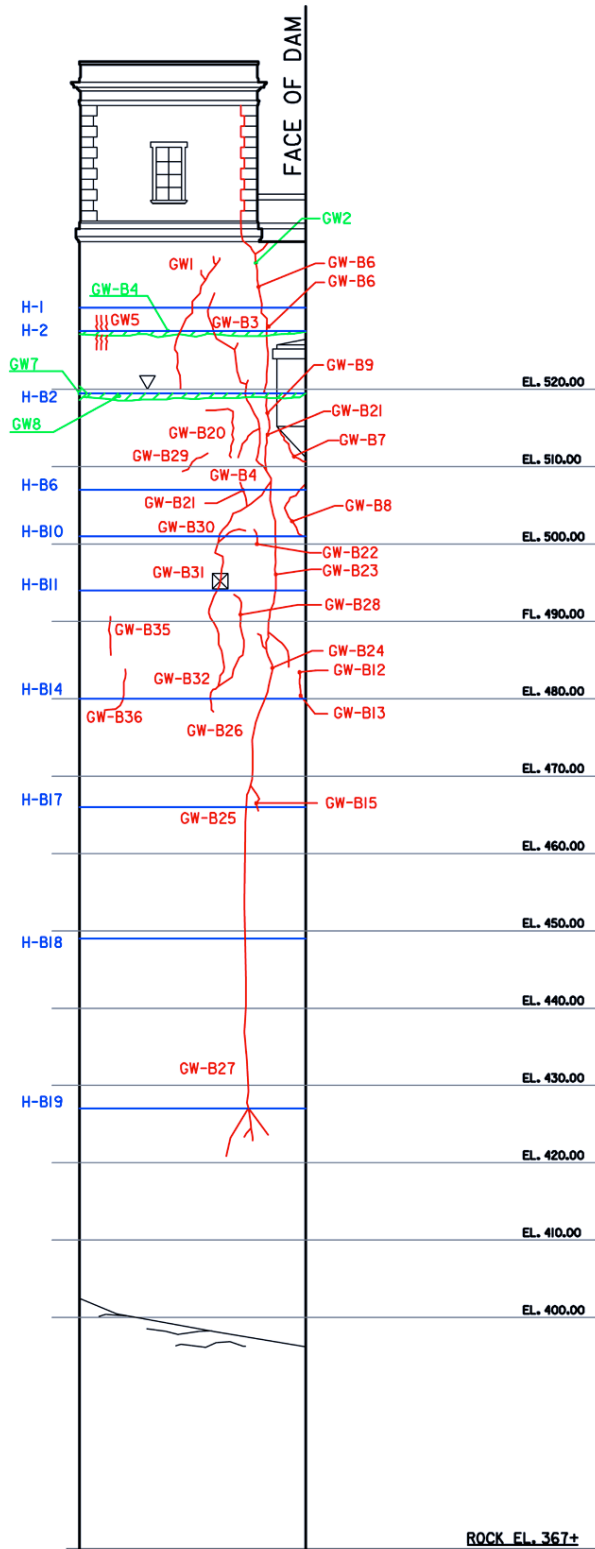
In the east face of the gatehouse (Figure 4), nearly all of the cracks emanate from the interface of the gatehouse and main body of the dam, the crack orientation is primarily diagonal to nearly vertical, and the crack widths and density of cracks are greater at higher elevations. At least some of the cracks were confirmed to extend through the thickness of the gatehouse walls.

Figure 4. Cracking in East Face of Gatehouse

- **Crack Group 1** consisted of cracks in the exterior of the east and west gatehouse walls, as described above (Figures 4 and 5). The cracks in this group were relatively interconnected, but not to the extent that portions of the gatehouse fractured and became dislodged. However, the gatehouse did appear to have displaced upward relative to the main dam by about 1/8” (3 mm). This displacement appeared to be somewhat larger at the west side of the gatehouse as compared with the east side. The displacement was evidenced by a crack in the gatehouse floor slab and a similar crack in the bridge sidewalk in front of the entrance to the gatehouse. At both of these cracks, the north (gatehouse) side was displaced upward relative to the south side, as though the cracks were out-of-plane shear cracks. This displacement suggested that the vertical cracking in the gatehouse walls adjacent to the dam face may have been interconnected enough to have resulted in a shear fracture along this plane. Vertical construction joints in this location, if present, would have facilitated this.

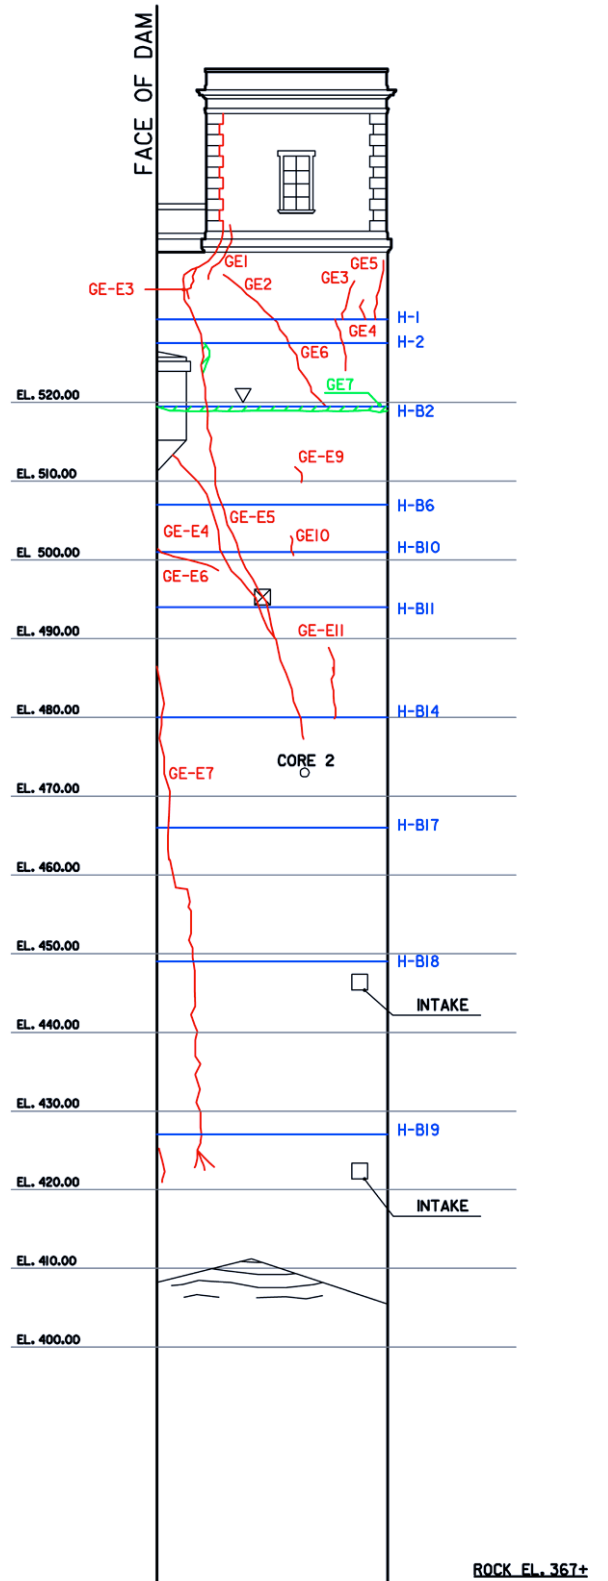
In the west face of the gatehouse (Figure 5), as with the east face, nearly all of the cracks emanate from the interface of the gatehouse and main body of the dam, the crack orientation is primarily diagonal to nearly vertical, the crack width and density of cracks are greater at higher elevations, and at least some of the cracks were confirmed to extend through the thickness of the gatehouse walls. However, comparing with the east face, the overall extent of cracking is greater in the west face and the orientation of the cracks is more vertical.

Figure 5. Cracking in West Face of Gatehouse

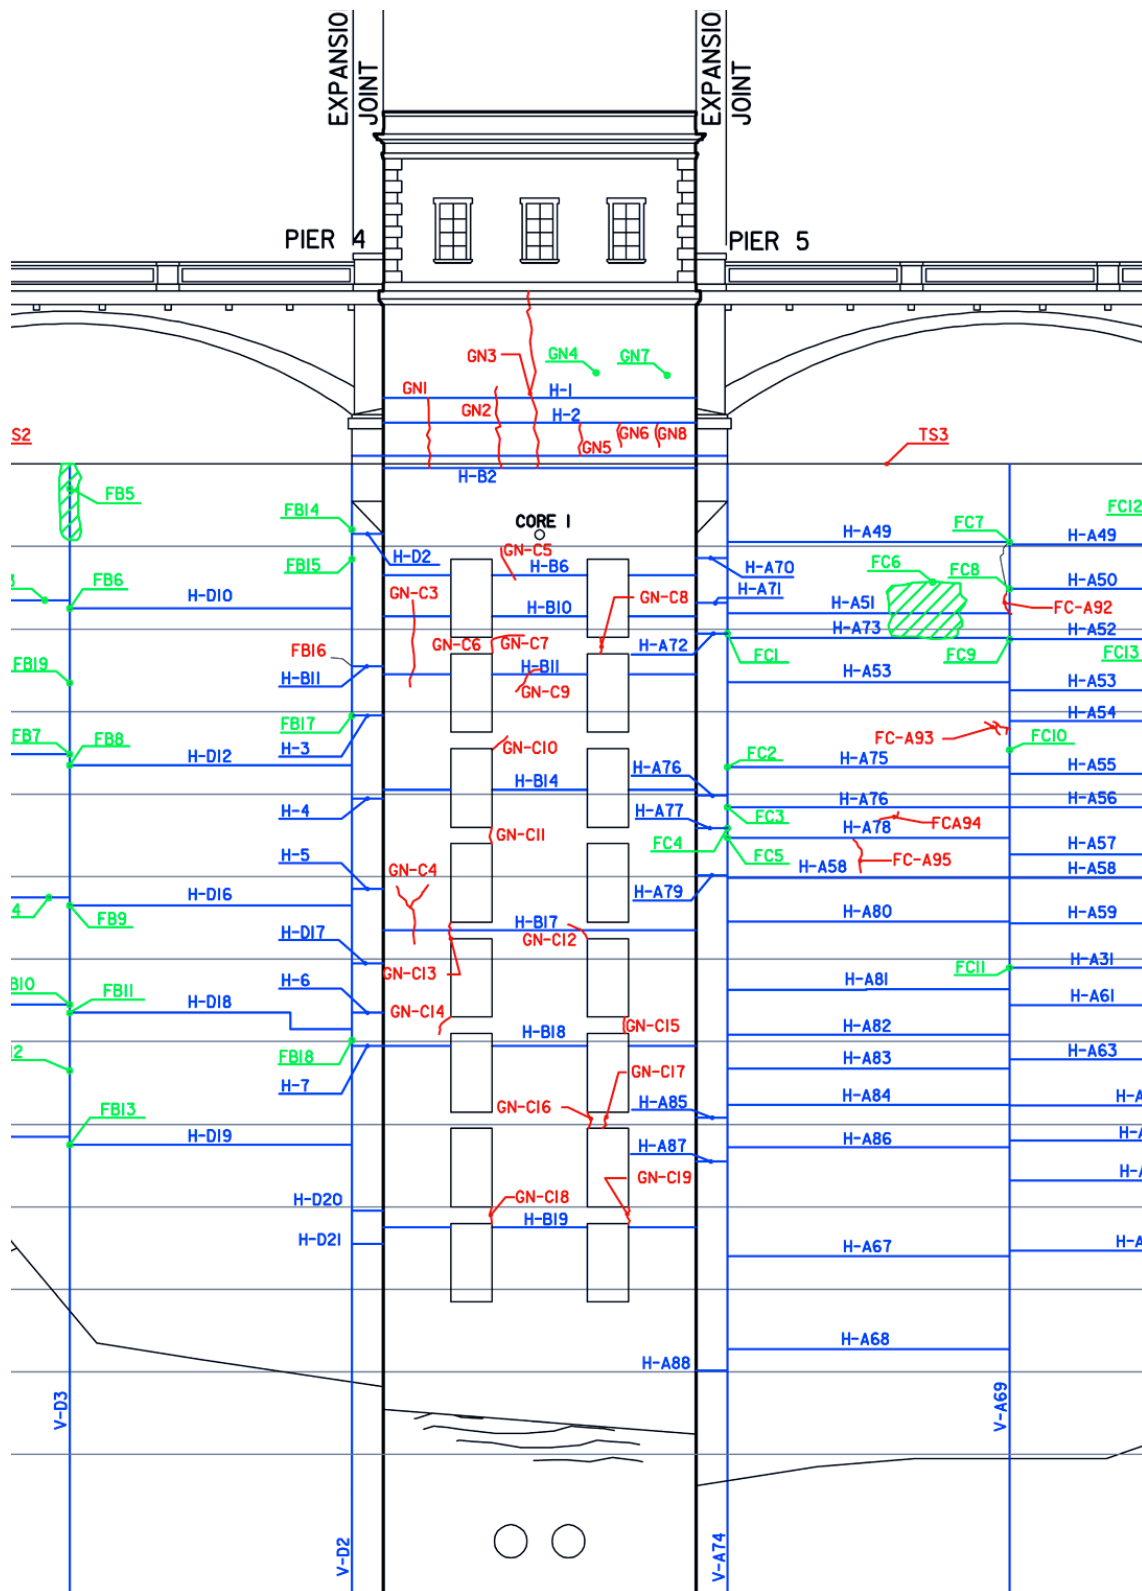
Figure 6. Cracking in Upstream (North) Face of Gatehouse

The cracking in the north face of the gatehouse (Figure 6) is not as extensive as the east and west faces, and the crack widths are generally narrower. Most of the cracks are vertical, although a few are horizontal and diagonal.

- **Crack Group 2** consisted of cracks in the exterior of the north gatehouse wall, also as described above (Figure 6). The most prominent of these cracks were vertical and located within the 20 feet (6 m) of gatehouse wall above the spillway crest. The longest and widest of these cracks was found at the mid-width of the wall and penetrated the full thickness of the wall. Less prominent cracks were also present below the crest, primarily toward the east side of the wall. Most of these cracks were vertical and the others were horizontal and diagonal.

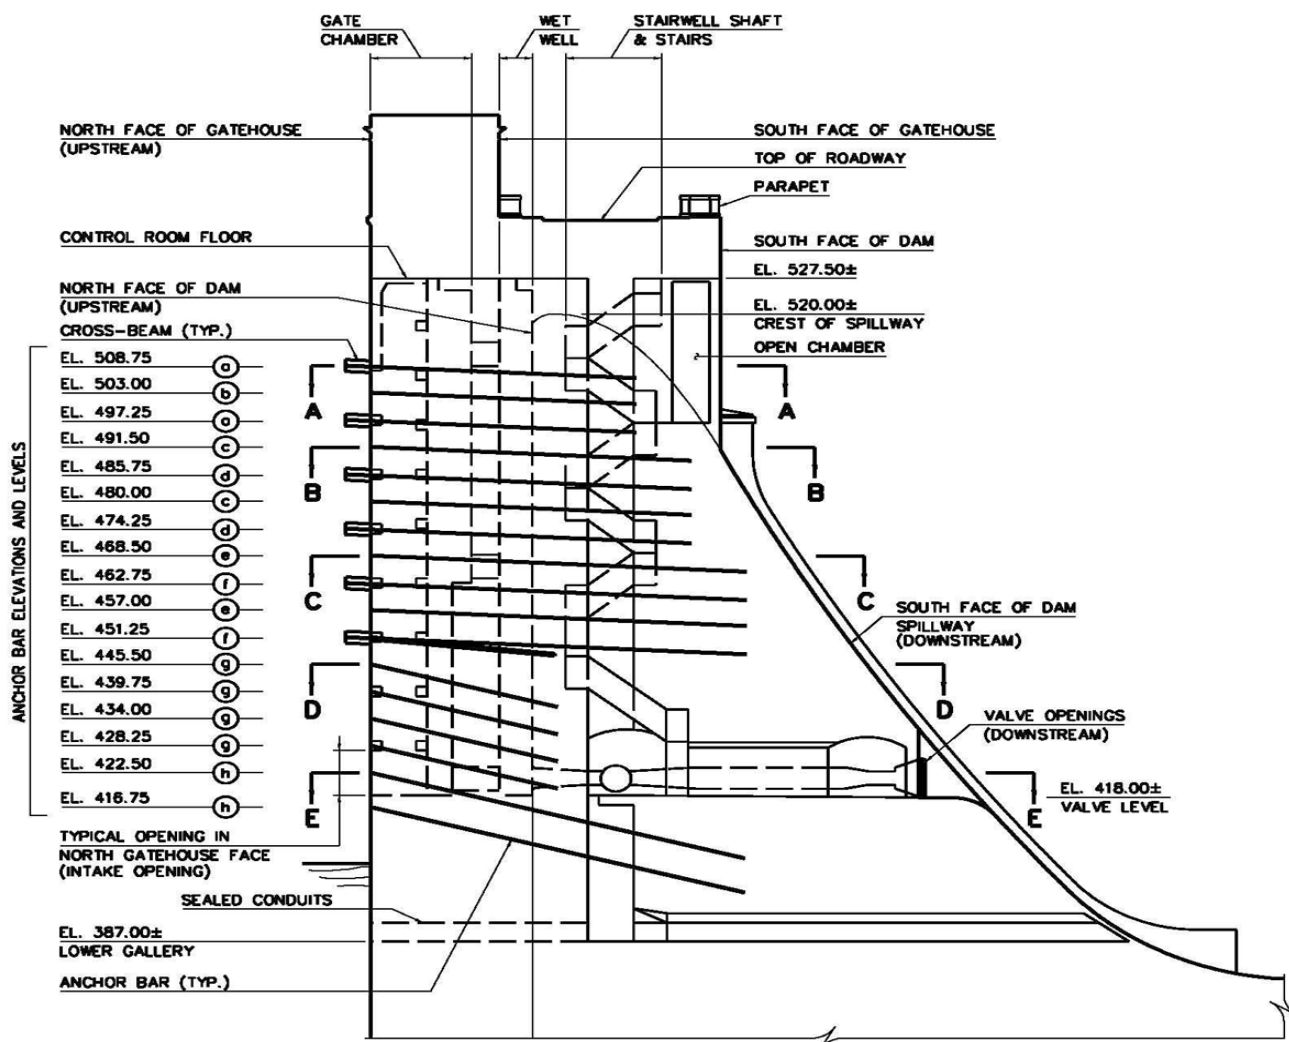
Figure 8. Gatehouse Typical Section (Elevation View)

- **Crack Group 3** consisted of cracks in the gatehouse floor slab located at about elev. 527.5 (160.8 m) (Figure 8). All cracks in this group were interconnected with each other, and also with several prominent cracks in Crack Groups 1 and 5. A prominent crack extended all the way across the floor between the east and west gatehouse walls, parallel to and about 2 feet (0.6 m)

- **Crack Group 4** consisted of cracks in the east and west gatehouse walls in the area below the bridge over the dam, within the interior of the dam (Figure 8). Of the most prominent cracks, most were full-height or nearly full-height vertical cracks, and the rest were horizontal. The less prominent cracks were generally diagonal. Many of the cracks emanated from the bridge girders where they framed into the gatehouse walls. These walls are reinforced concrete and about 18 inches (450 mm) thick, which is somewhat thin relative to the bridge reactions they must carry.

- **Crack Group 5** consisted of cracks in the east and west gatehouse walls north of the bridge area, also at the interior of the dam (Figure 8). These cracks were mostly full-height cracks or nearly full-height vertical cracks.

- **Crack Group 6** consisted of cracks in the interior of an open chamber room near the top of the gatehouse, at the interior of the dam (Figure 8). These cracks included a full-height vertical crack near the mid-width of the south wall, a horizontal crack in the north wall, and full-height vertical cracks with branching cracks in the east and west walls.

- **Crack Group 7** consisted of cracks in the stairwell walls (Figures 8 and 9). The vast majority of these cracks were vertical cracks in the east and west stairwell walls within the 100-foot (30-m) vertical range between the crest at elev. 520 (158 m) and the valve room at elev. 420 (128 m). These vertical cracks were concentrated toward the top of this range. In addition, there were a few horizontal cracks in the north and south walls, the most prominent of which were near the dam crest.

gatehouse near the upstream dam face, with resulting shear and bending in the east and west gatehouse walls, particularly near the wet wells (Figures 8 and 9). The shear and bending could produce vertical shear cracks and vertical flexural cracks consistent with Crack Groups 1 and 5. A similar mechanism, in which the top of the main dam is compressed while the bridge over the dam is not, could contribute to cracking consistent with Crack Group 4.

- One system consists of 26 anchors, with the anchors directly attached to the north face of the gatehouse (Figures 8 and 9). To prevent shearing of the gatehouse concrete during post-tensioning, these anchors were tensioned to a modest load of 50 kips (223 kN) and grouted in two stages, with the second grouting stage being bonded to increase the ultimate capacity of the anchors. A special rubber "wiper" detail was developed to enable this two-stage grouting in the relatively deep underwater conditions such that the bond zone would be fully grouted, while avoiding leakage of the grout into the free-stressing zone. The key in developing the wiper detail was to select a rubber material and geometry that would enable insertion into the drilled holes without binding, while also providing a tight enough seal to withstand grouting pressures.

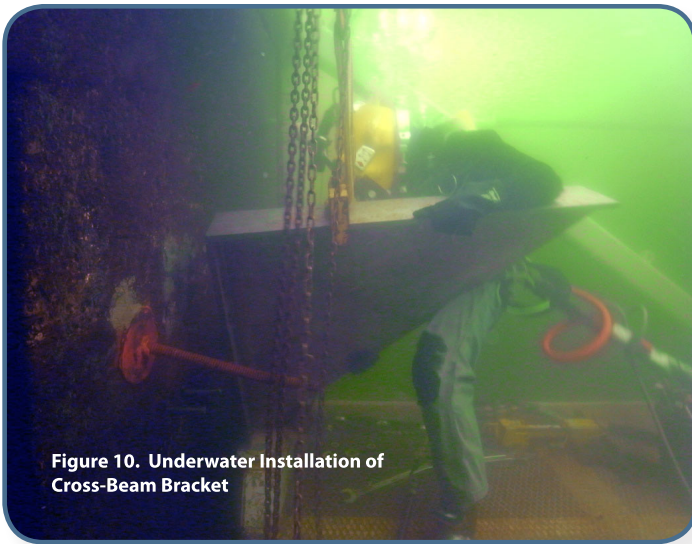
Figure 10. Underwater Installation of Cross-Beam Bracket

- As noted above, nearly all of the work needed to be performed underwater, in water depths reaching more than 100 feet (30 m). This required rotating teams of divers using two decompression chambers and helmet-mounted underwater cameras, and maintaining continuous audio communication between the divers and supervisors at the surface (Figure 10).

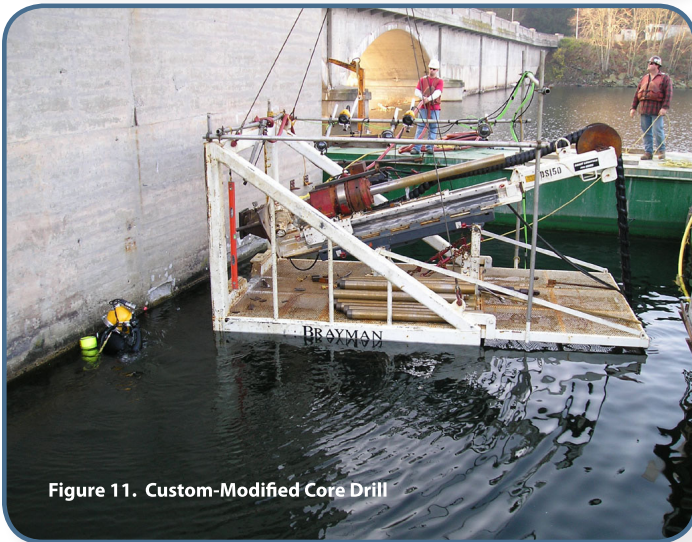
Figure 11. Custom-Modified Core Drill

- For anchor drilling, a core-drill was custom-modified to “breathe” underwater and was equipped with sensors to monitor hydrostatic water pressure (Figure 11). The drill was positioned on a specially designed drill cart equipped with four cameras, and was operated remotely from the surface. The drill and drill cart were precisely positioned to meet the tight construction tolerances by attaching them to an extensive drilling template consisting of vertical and horizontal steel H-beams.
