Failure of Sella Zerbino Secondary Dam in Molare, Italy

Irfan A. Alvi, PE, President & Chief Engineer, Alvi Associates, Inc.

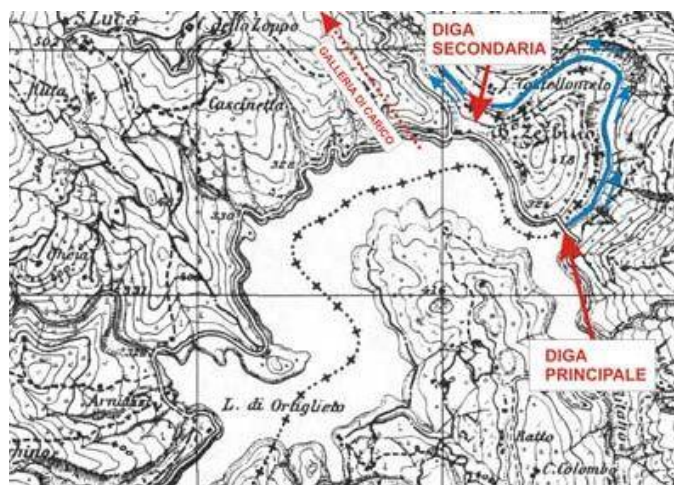
Figure 3. Bric Zerbino Main Dam ("Diga Principale") and Sella Zerbino Secondary Dam ("Diga Secondaria") [6]

The Sella Zerbino secondary dam augmented the main dam by closing a saddle-shaped gap in the rim of the reservoir, about 1000' northwest of the main dam (Figure 3) [4]. The secondary dam was a straight concrete gravity dam with a height of 46', a crest length of about 360', and no spillway or outlet (Figure 7).

Finally, the secondary dam failed on August 13, 1935. The apparent mode of failure was overtopping of the dam, resulting in erosion of the rock at the toe of the dam, in turn causing sliding and overturning failure. As further evidence of the low quality of the geologic formation, little remained of the secondary dam and its foundation after the failure, and geologic investigations after the failure indicated that while the main dam was founded on compact serpentinites, the secondary dam was founded on highly-jointed schistose rock with intense foliation and slaty cleavage (Figure 8), which many experts concluded was inadequate for a dam foundation [2].
