# Dam Safety

VOLUME 9 | ISSUE 3 | 2011

# GATEHOUSE ANCHORAGE System for Prettyboy DAM

IRFAN A. ALVI, P.E.

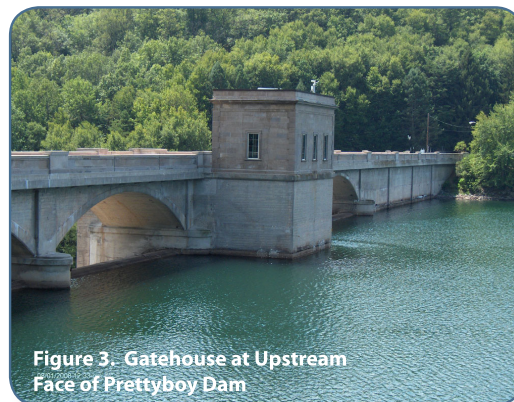
Figure 3. Gatehouse at Upstream Face of Prettyboy Dam

Control of water flow through the dam is via a concrete gatehouse that is monolithic with the dam (Figures 3, 8, and 9) and rests directly on the foundation rock. The gatehouse is located at the upstream (north) face of the dam, near the middle of the dam's length. The gatehouse is rectangular in plan and is 38'-0" (11.6 m) wide parallel to the dam axis and 63'-7" (19.4 m) wide transversely, of which 29'-3" (8.9 m) projects outside the upstream face of the dam. A stairwell is also present in the gatehouse in the portion of the gatehouse within the main body of the dam.
